The Sunshine Skyway collapse, May 9, 1980

One of the most infamous ship-bridge collisions in the United States occurred on the morning of May 9, 1980, when the 606-foot, 35,000-dwt *Summit Venture* hit the Sunshine Skyway in St. Petersburg, Fla. Thirty-five people fell to their deaths from the collapsed span.

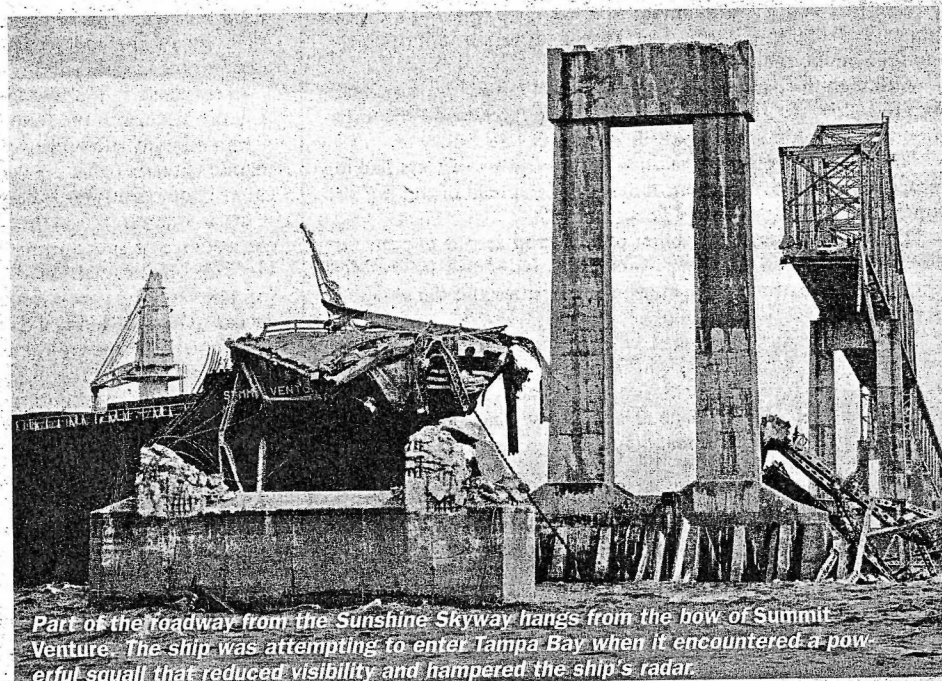
Part of the roadway from the Sunshine Skyway hangs from the bow of *Summit Venture*. The ship was attempting to enter Tampa Bay when it encountered a powerful squall that reduced visibility and hampered the ship's radar.

superstructure off the starboard bow and immediately realized that far from being in Cut "A," *Summit Venture* was south of the main shipping channel. According to the Coast Guard's *Findings of Fact*, "At 0732 in quick succession, he ordered left full rudder, a double-full astern bell, and the anchors let go. At 0733, with the engines going astern and the rudder hard left, the starboard bow of the *Summit Venture* collided with bridge pier 2S." The force of the impact knocked loose the top of the pier, and a 1,000-foot section of the roadway, including 612 feet of the main span, fell into the water. Pier 2S collapsed, and piers 1S and 3S were severely damaged.
